## Japanese Knotweed

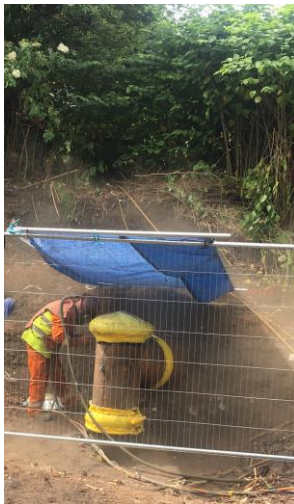
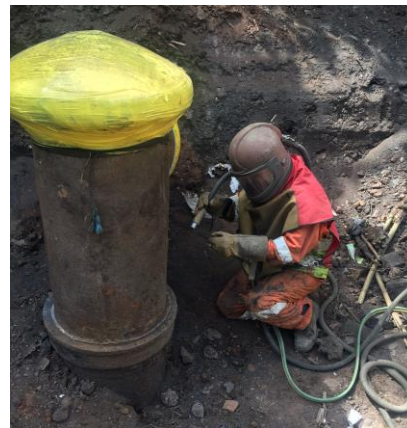
After the call, Mark and his colleague Mark Cartwright quickly made their way to the site to meet with two senior GDN engineers and assess the damage. On close inspection they realised that two joints and the tee on the 18" off 18" unit were badly damaged.

Detailed measurements were taken and, almost immediately, back at PLCS headquarters, work was underway to manufacture two bespoke polyurethane-coated nylon moulds for each of the joints as well as a metal case to seal the escape from the main valve.

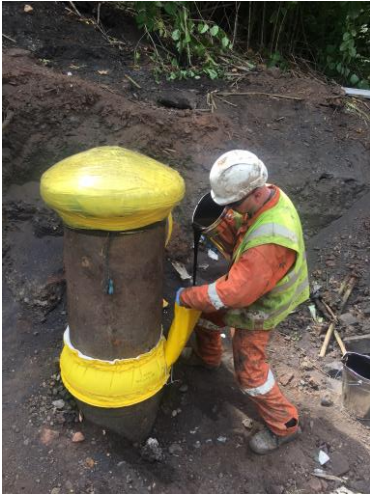
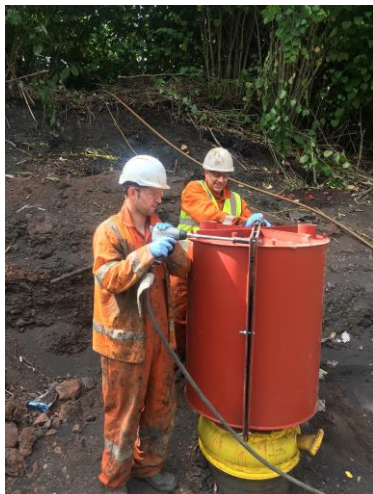
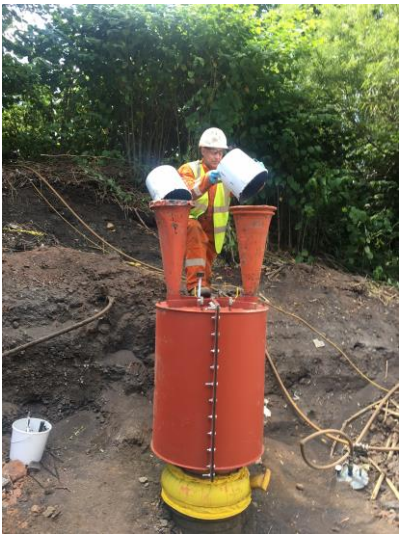
At 8.30am the following morning, a team of five from PLCS Ltd arrived on site where they first had to manoeuvre the repairs kits and materials from the roadway down the embankment to where the actual repair site was located. There, the repairs were carried out successfully and completed by 2.00pm with the metal case involving 224 litres of encapsulant.

The PLCS team fitting the metal casing were Alan Clarke, James Poole, Ross Fairley, Chris Derby and Mark Cartwright. The fabric repair kits were fitted by Chris Derby and Alan Clarke.
