When Experience Really Counts.....

Such was the case with the recent low-pressure gas escape repair of a 6" off 16" cast iron under pressure damper tee. After we received the call, PLCS engineers Mark Bailey and Ross Fairley visited the site to assess the repair and take measurements for the preferred solution – a special fabric kit measuring 1.5 metres long with a circumference of 2.2. metres.

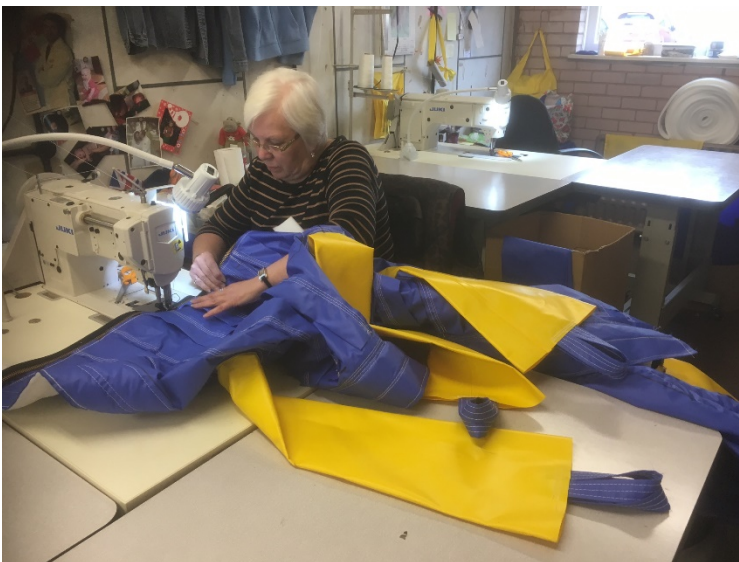
Measurements and photos were immediately sent back to the PLCS Technical Office where Manager Mark Perry began designing the kit to completely encase the tee and incorporate the damper plate valve on the branch.

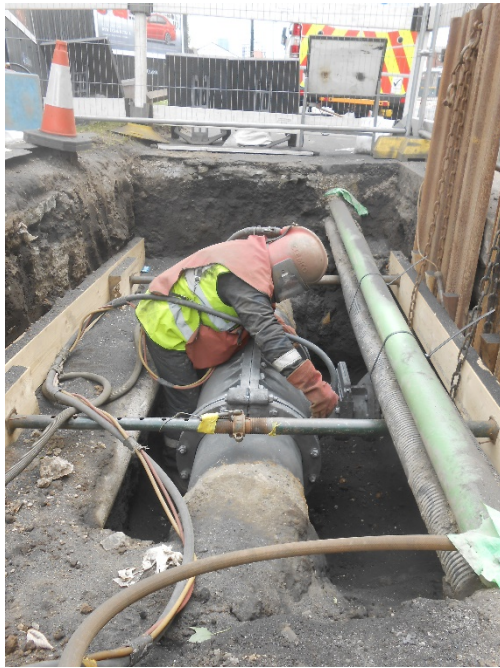
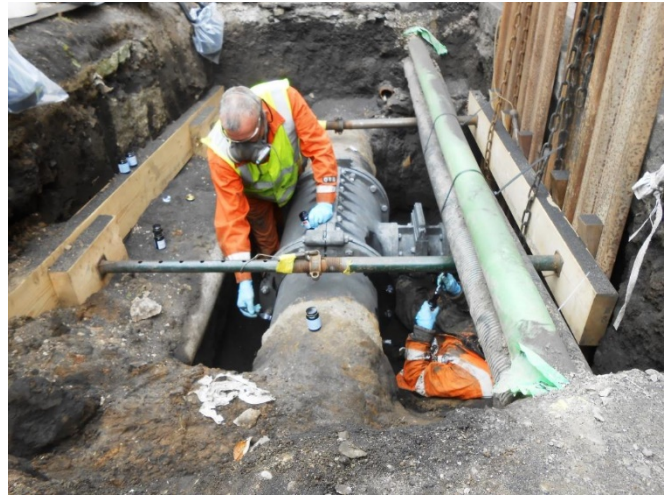
Grit blasting and descaling were followed by the application of a primer that was specially developed by PLCS to promote adhesion of the Flexapress Encapsulant to the pipe and fitting, whilst at the same time providing a secondary anti-corrosion barrier.

The effectiveness of the repair depended in part on achieving an equal depth of sealant coverage fitting, the consistency of which was critical to ensure the longevity of the seal.

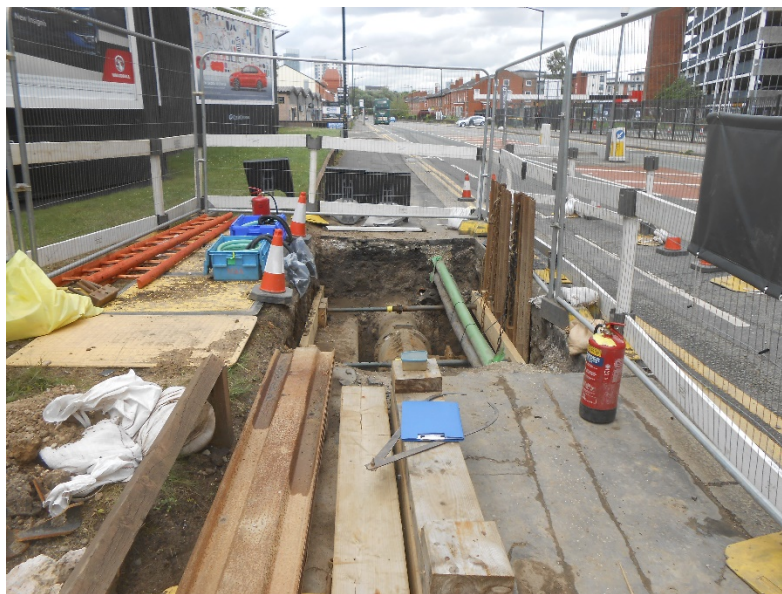
To avoid the weight of the heavy sealant (a quarter ton) slumping and distorting the mould, the teams created and fitted a strategically-placed framework of internal and external supports around the repair area.

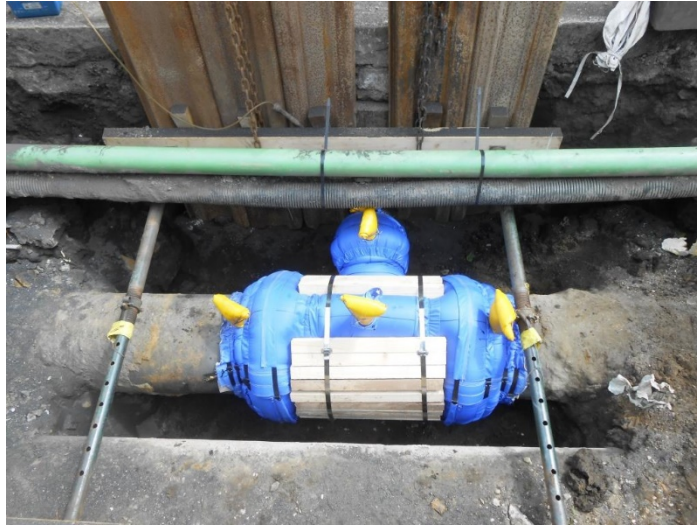
Once the kit supports were in place, the mould was filled and pressurised with 144 litres of Flexapress Encapsulant which is approved by the Gas Networks to meet and exceed the GIS LC8 Part One Specification for the permanent repair of ferrous gas main joints and fittings.
