## As Complicated as It Gets

On the 13<sup>th</sup> of February 2019, the PLCS Technical Office received an urgent call regarding the repair of a 48" Westwood & Wright valve located in the centre of a very busy city centre junction.

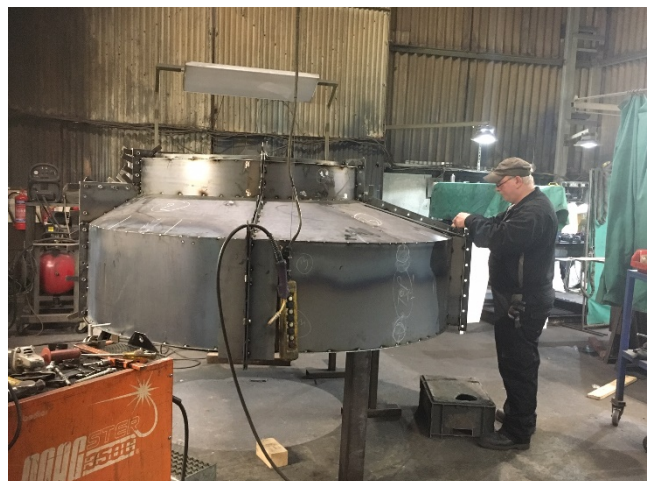
A full assessment of the escape took place with comprehensive measurements taken and immediately sent back to the PLCS technical office where the team began working on the manufacture of a fabricated steel mold.

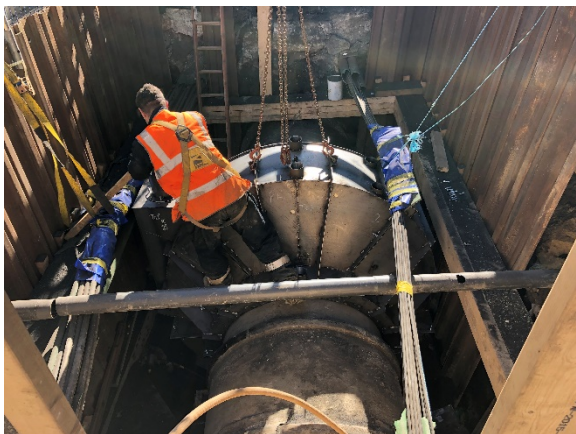
The proximity of multiple utilities around the valve resulted in the mold being constructed in six different segments which would allow each piece to be inserted into the excavation between the cables.

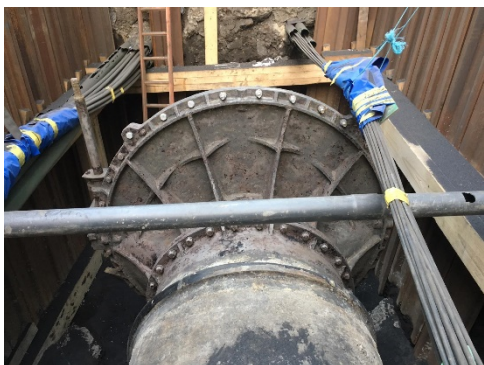
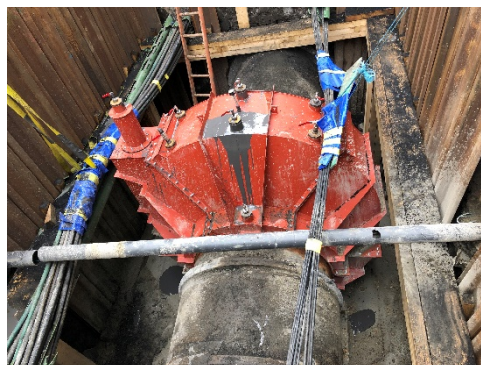
Due to the complicated nature of the repair, a trial fit of the fabrication was required before the final installation. This trial was successfully undertaken on the 25<sup>th</sup> of February with the final repair taking place on the 1<sup>st</sup> of March.

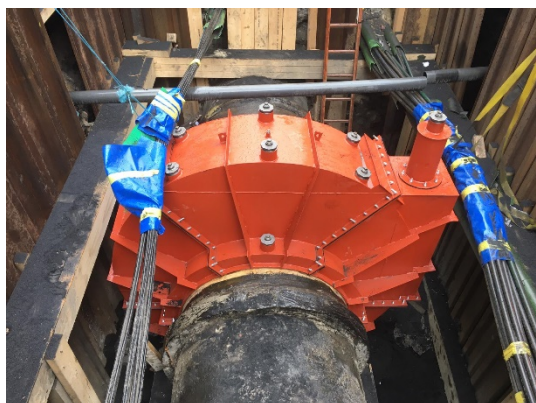
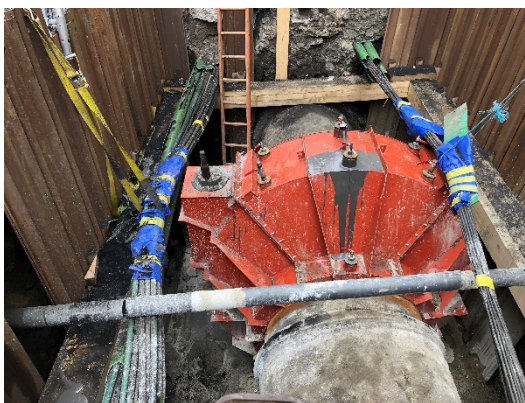
A follow up visit was necessary the next day to remove the spindle housing in order to retain the operational capability of the valve.
